3RD FLOOR BOILER HOUSE SECTION VII ROOM 7.06 F

**Non-TCRA Building Assessment
Avtex Fibers Superfund Site**

Section/Building:	Section VII 3rd Floor Boiler House	Date & Time: 1/3/00 1030	
Room No./Description:	Room 7.06 F	Field Team: WW, ST, JT

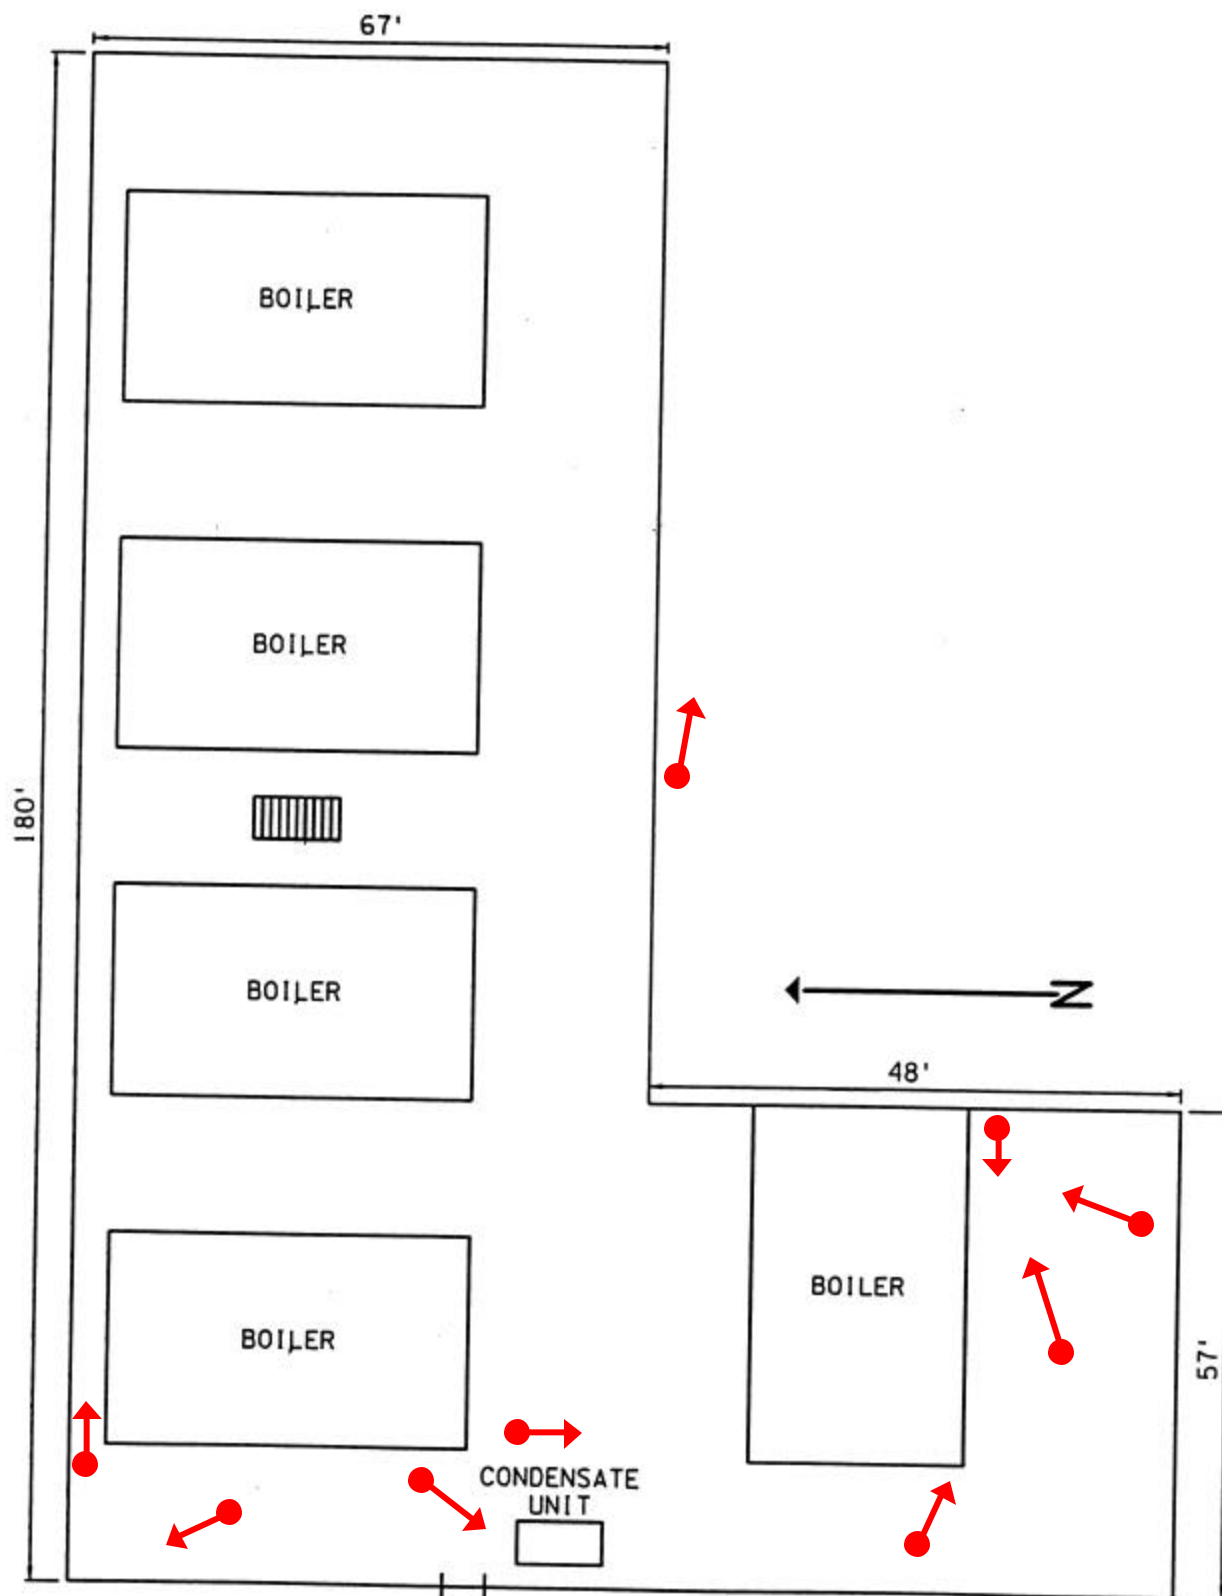
Structural Concerns: Y/N Yes, some floor grates are buckled, and window frames are falling off the building in some areas.

Additional Comments: The room contains approximately 100 Hg/Na vapor lights. There is a yellow solid in and around the coal hopper in the SE corner of the room.

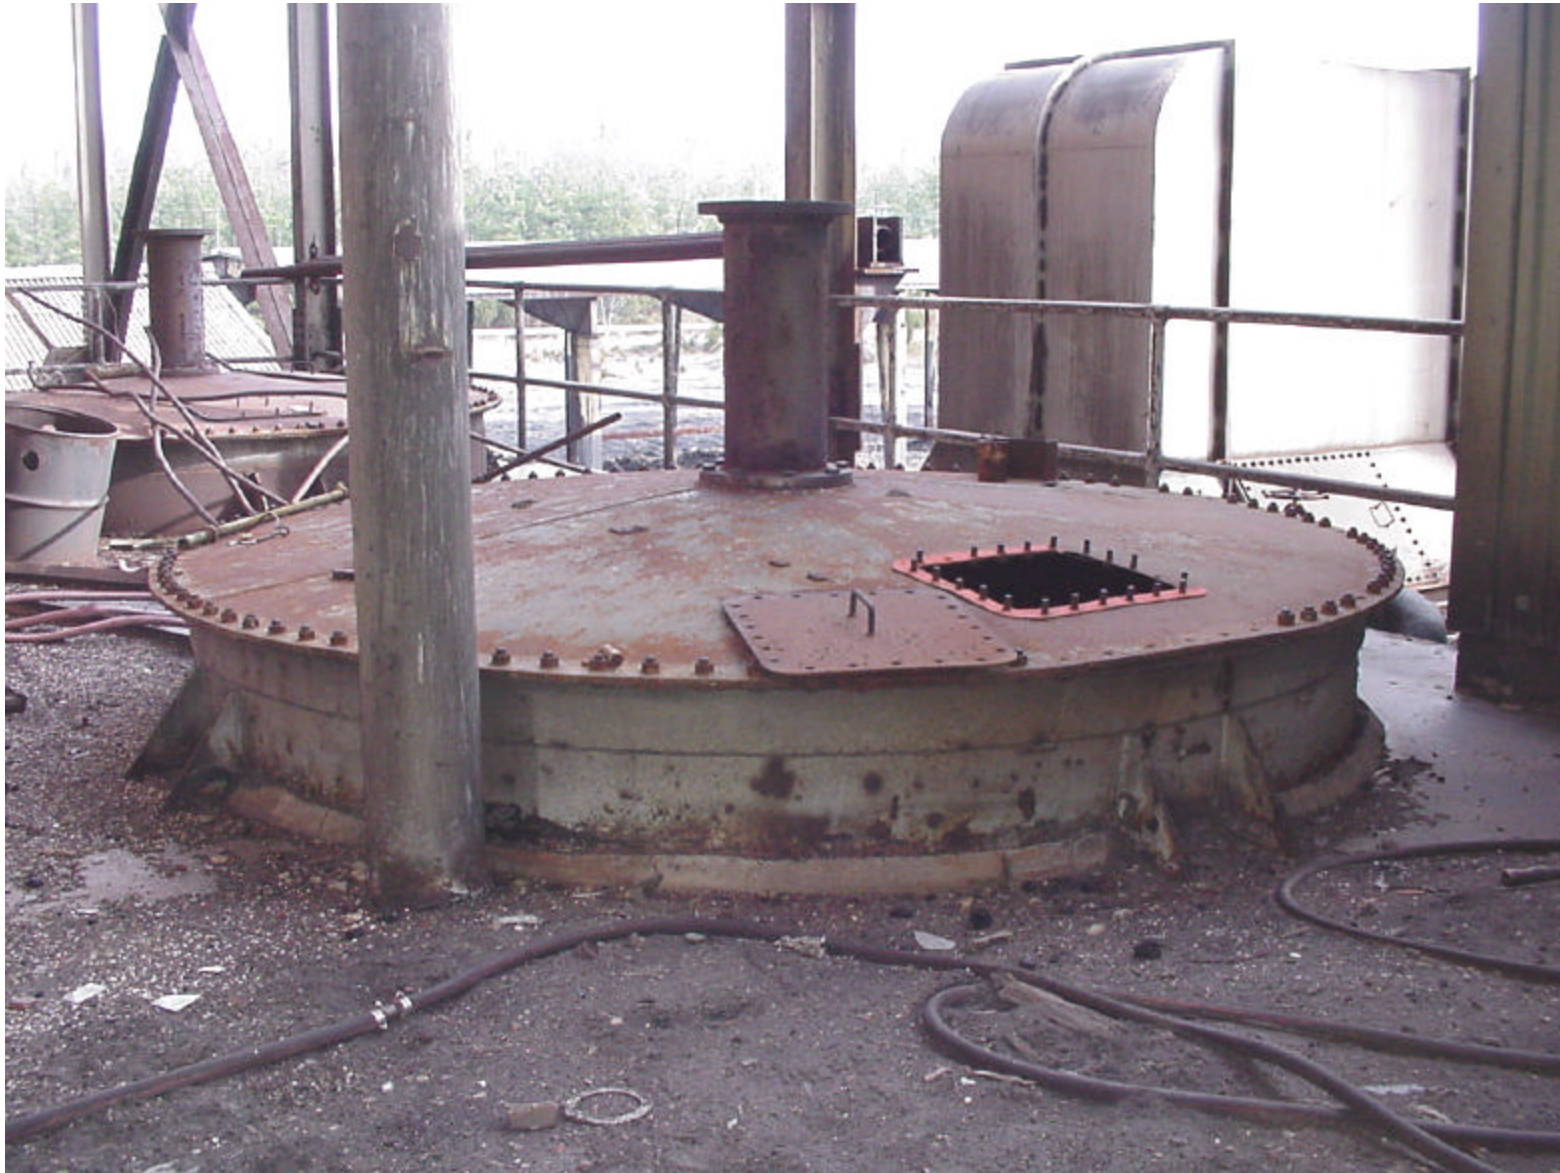
Photograph ID	Date Taken	Section #	Room #	Room Description	Description
MVC-677		VII	7.06F	3nd Floor Boiler House	View of 2nd floor roof, looking east

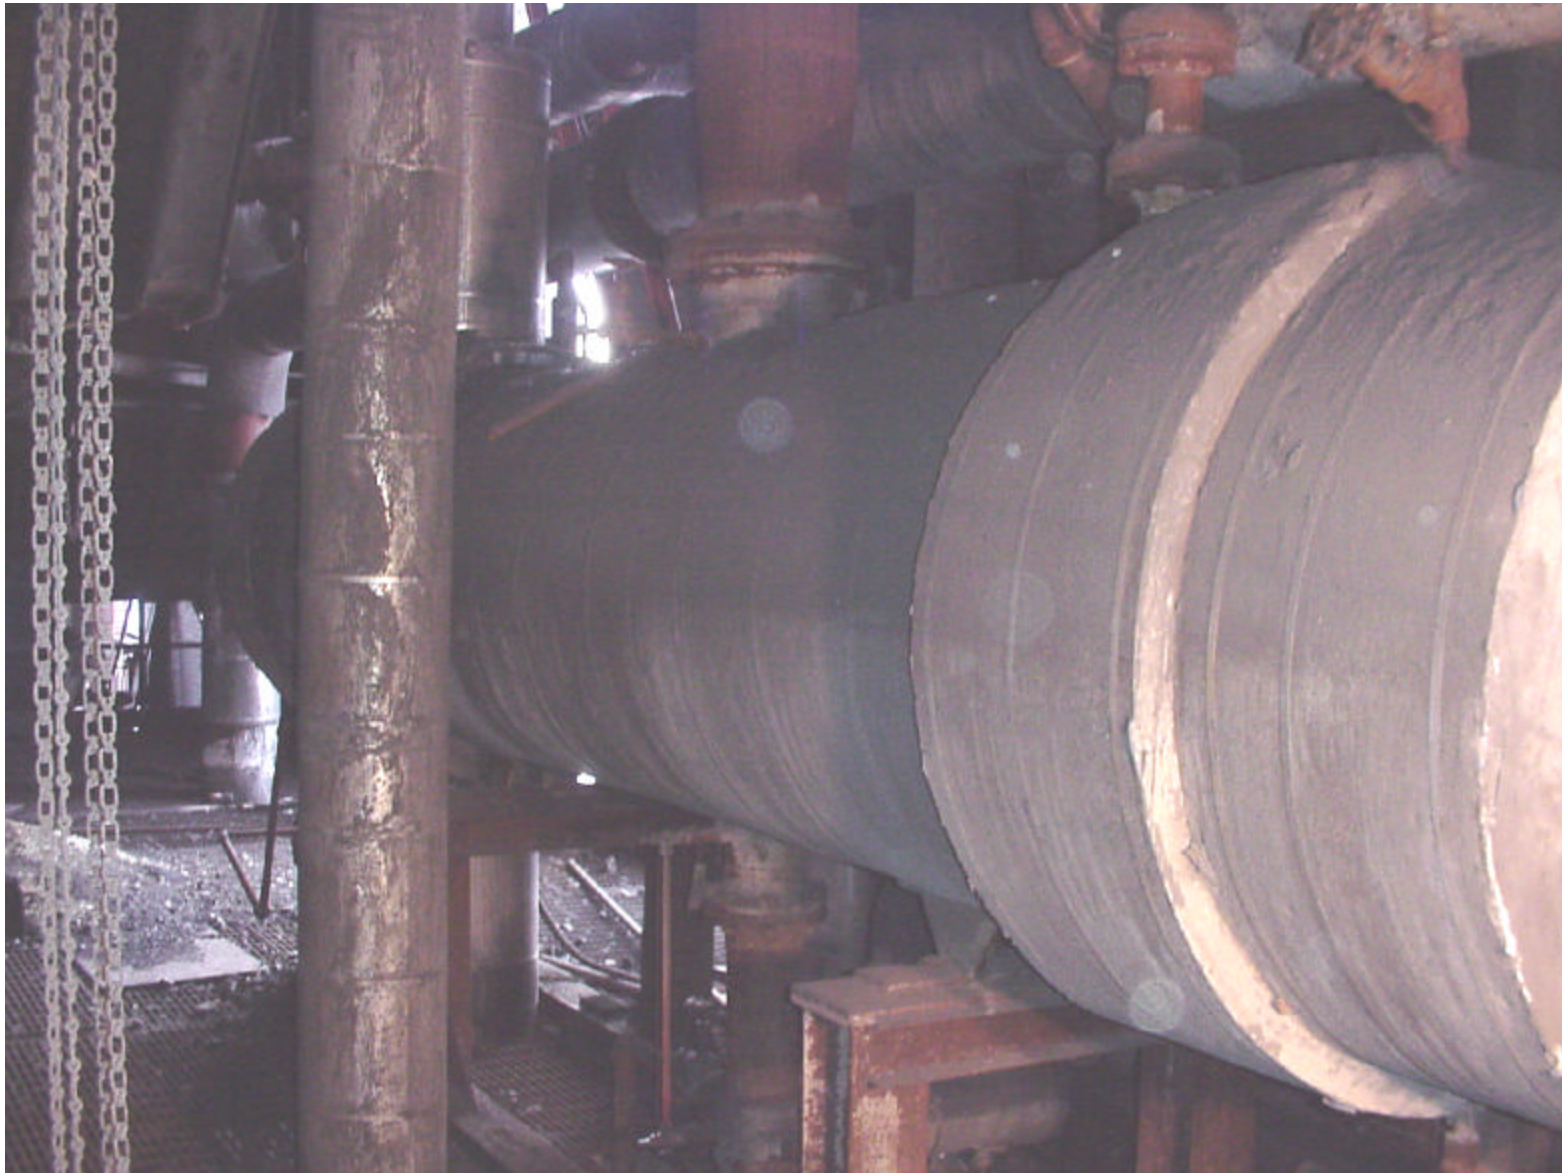
Photograph ID	Date Taken	Section #	Room #	Room Description	Description
MVC-685		VII	7.06F	3nd Floor Boiler House	Condensate unit in west side of room

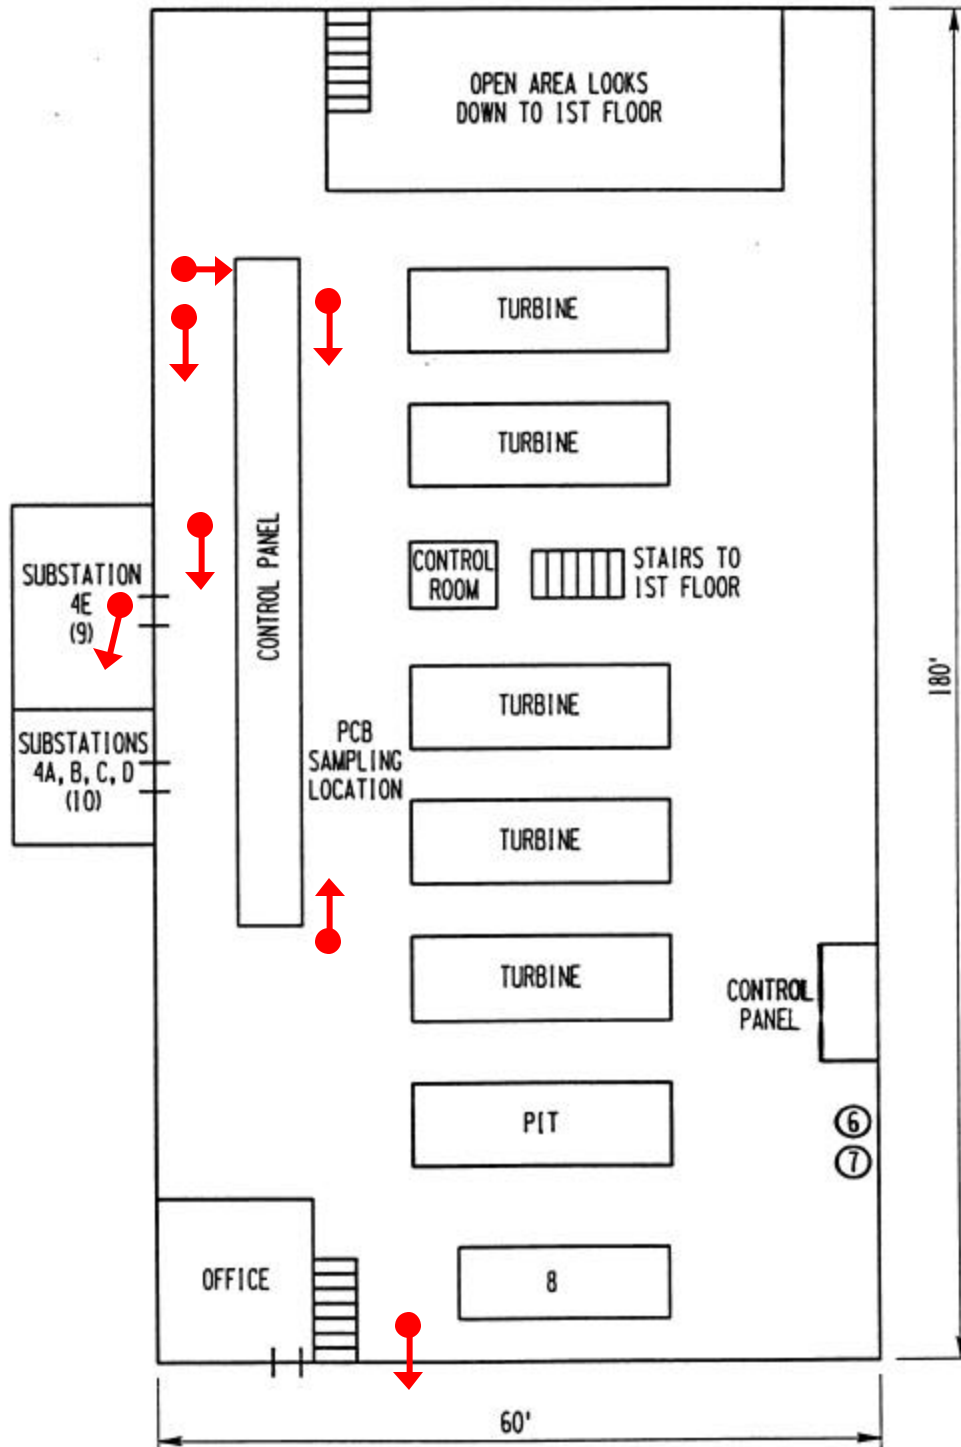
POWER HOUSE 3ND FLOOR SECTION VII ROOM 7.05 B

Additional Comments: There are oil stains along the N floor behind the switches and transite paneling outside.

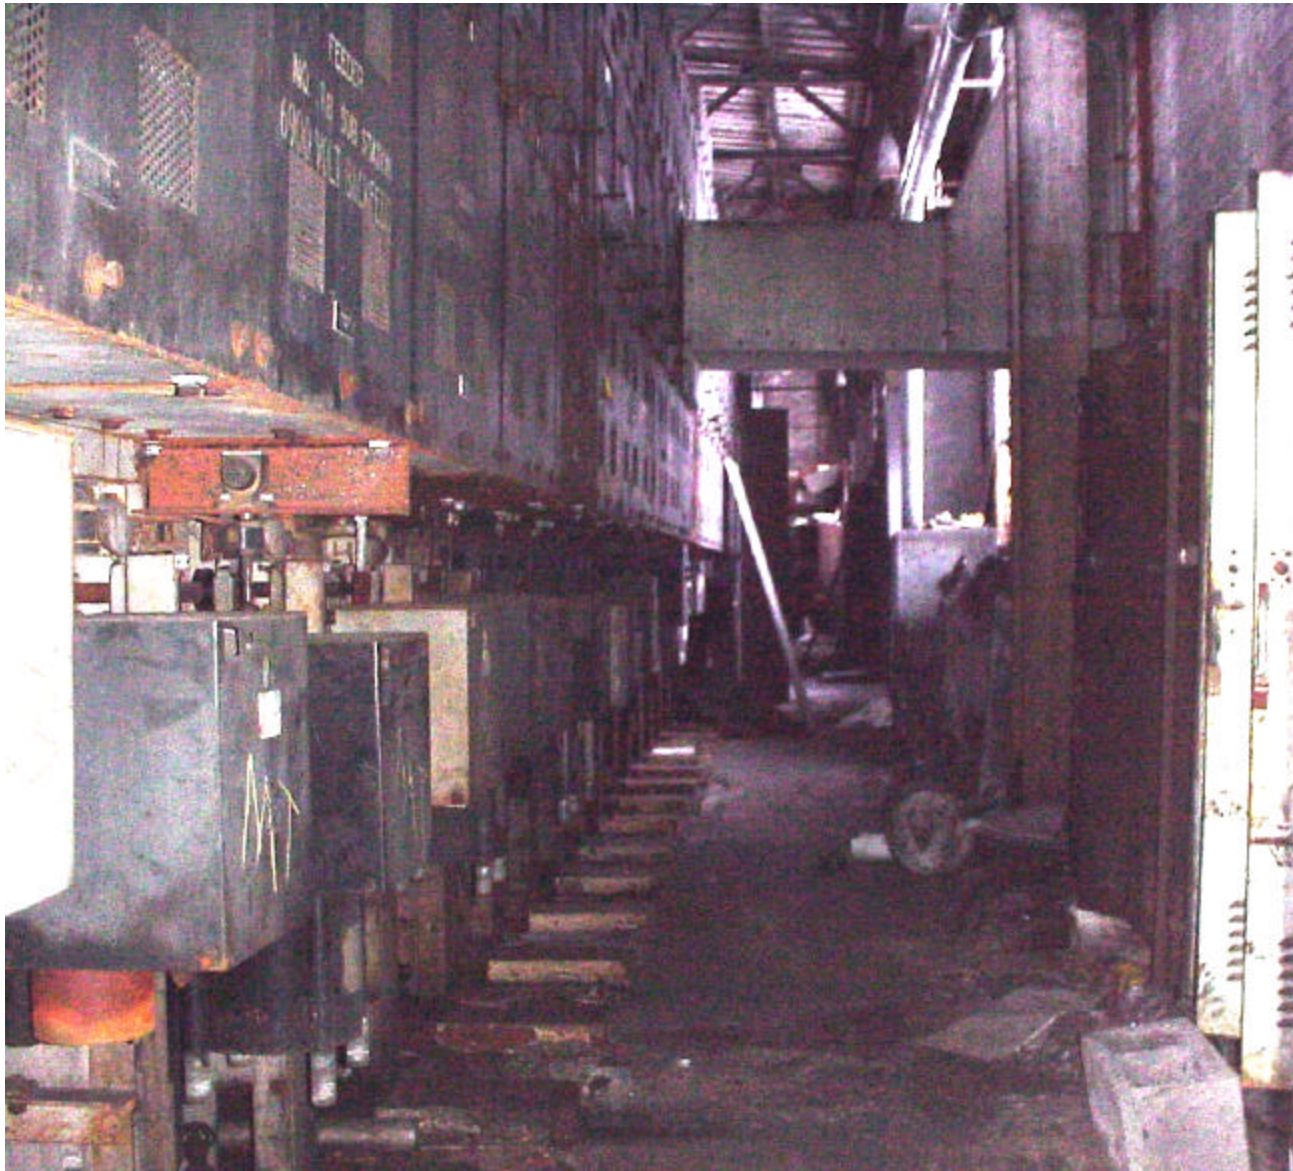
Photograph ID	Date Taken	Section #	Room #	Room Description	Description
MVC-733		VII	7.05B	2nd Floor Power House	Looking west from northeast corner of room, behind switchboxes

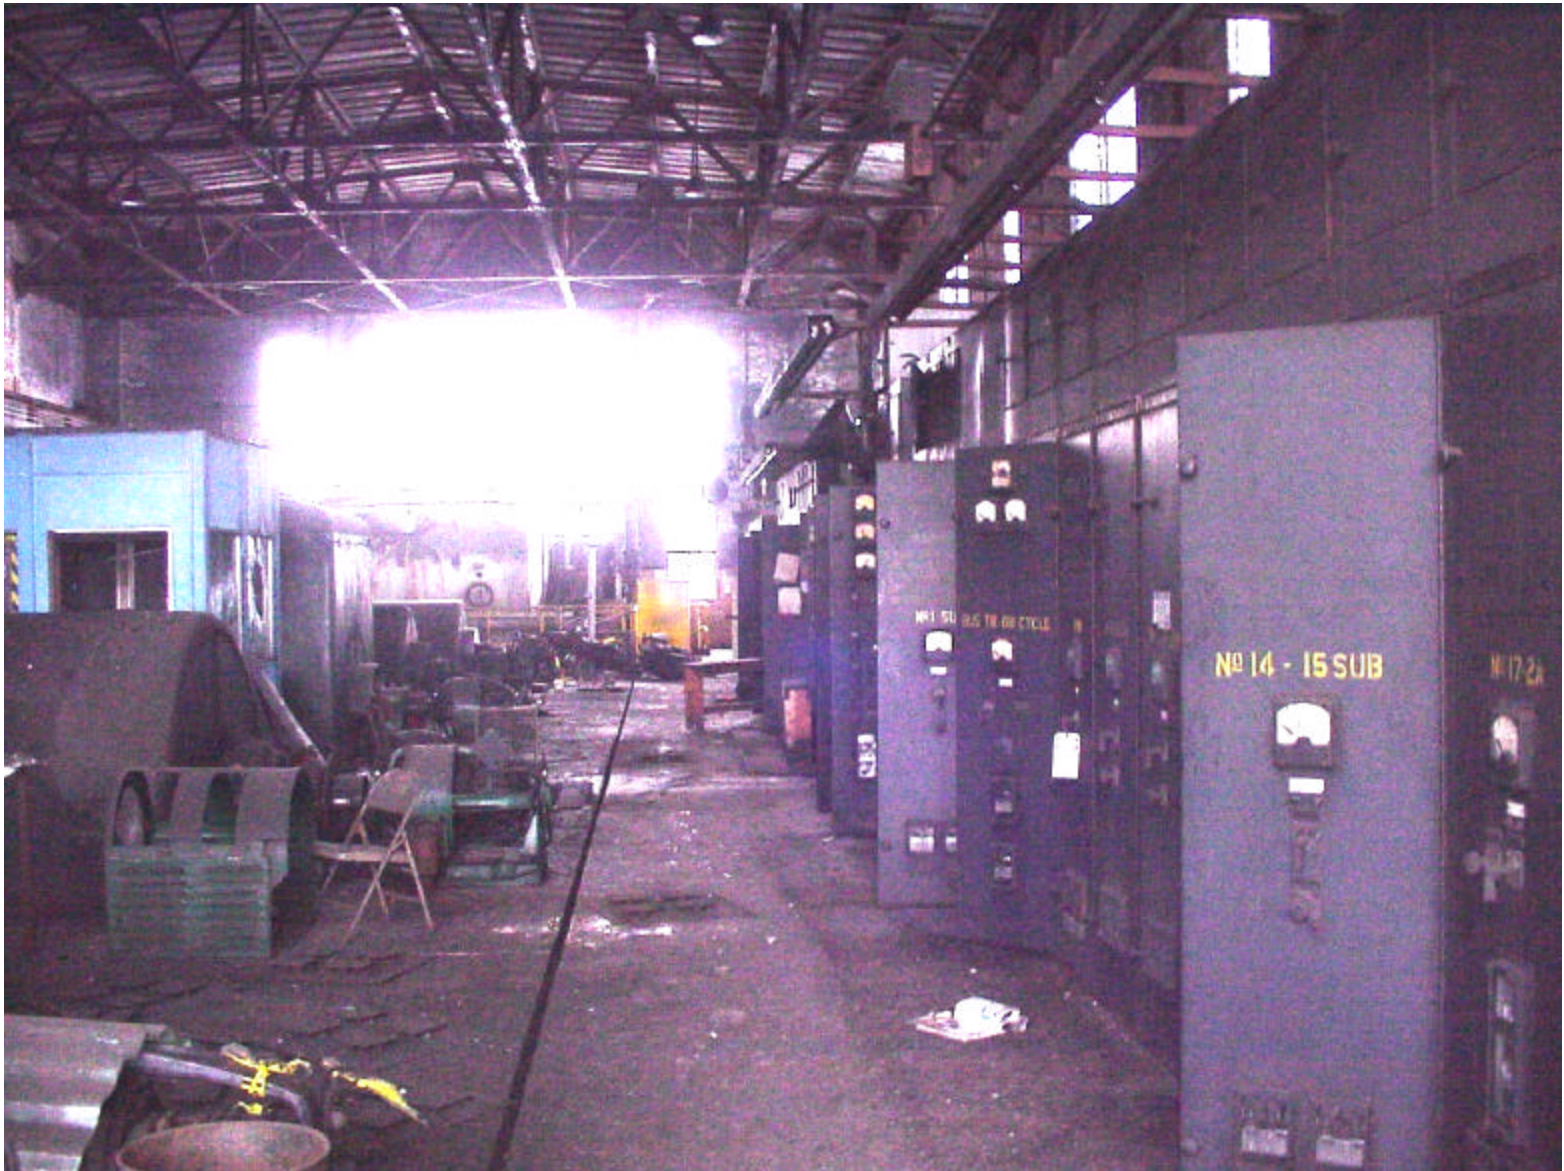
Photograph ID	Date Taken	Section #	Room #	Room Description	Description
MVC-734		VII	7.05B	2nd Floor Power House	Looking west from northeast corner of room, in front of switchboxes

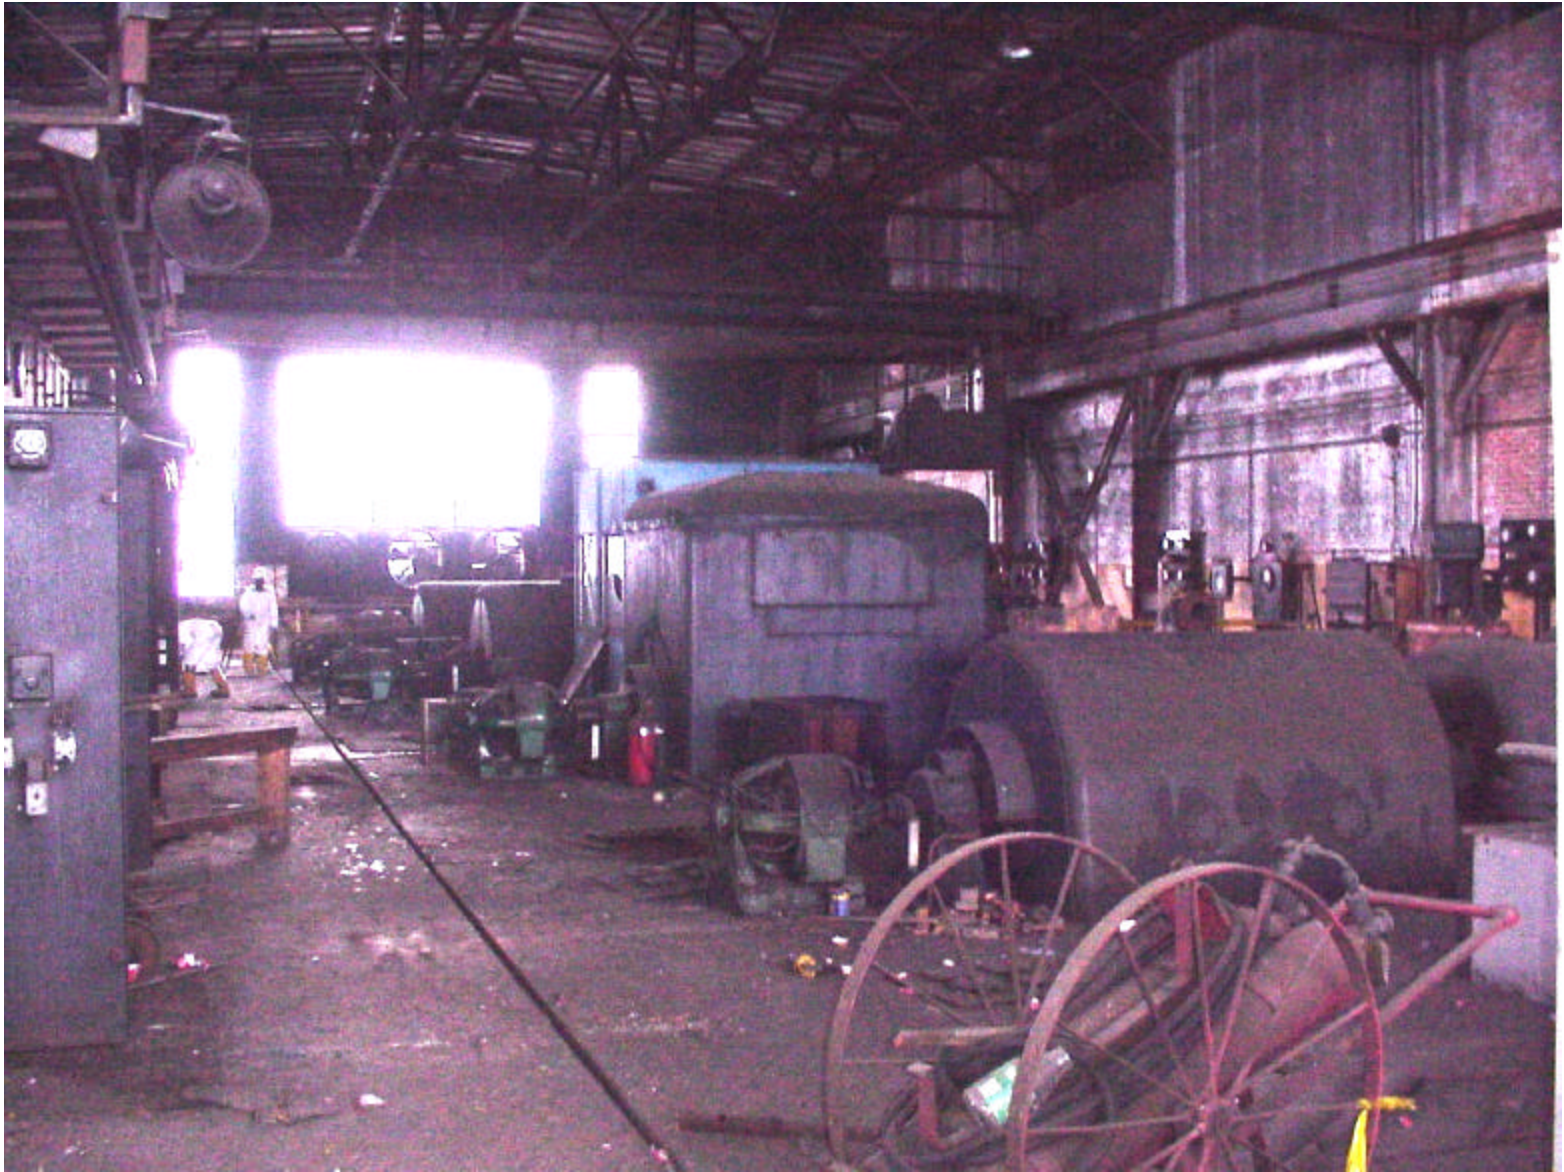
Photograph ID	Date Taken	Section #	Room #	Room Description	Description
MVC-735		VII	7.05B	2nd Floor Power House	General view of room looking east from northwest corner of room

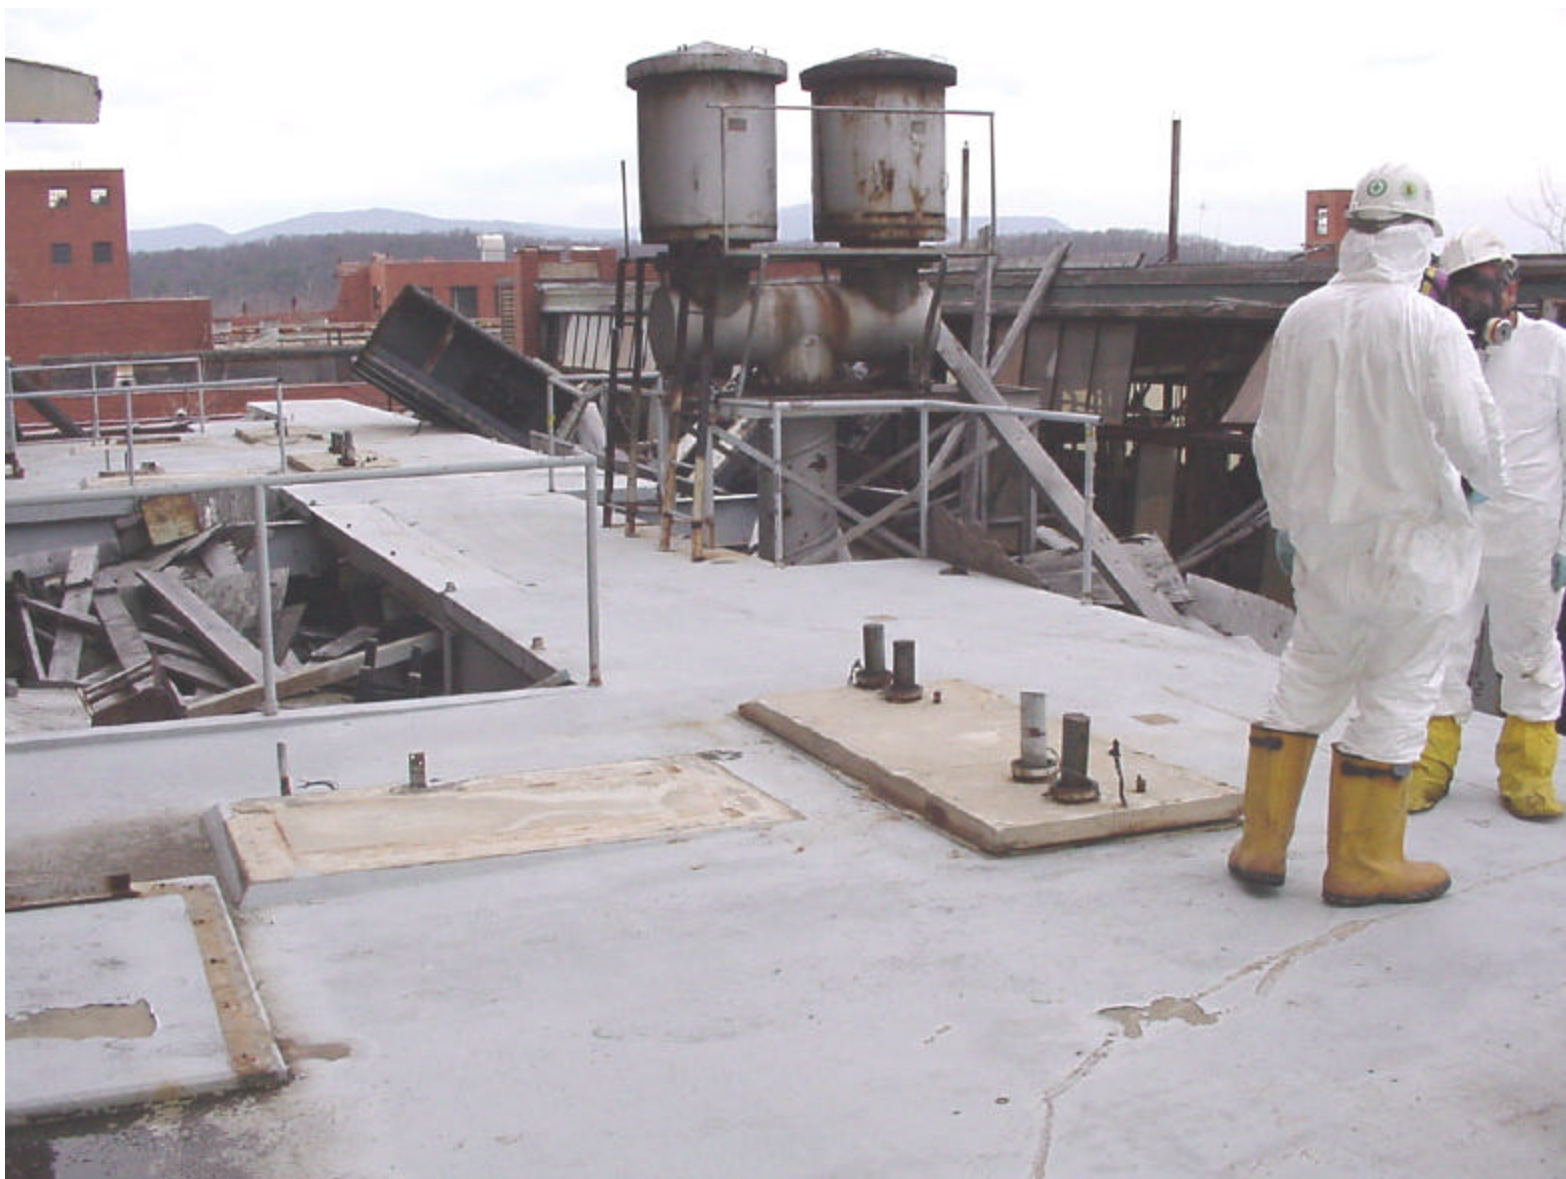
Photograph ID	Date Taken	Section #	Room #	Room Description	Description
MVC-736		VII	7.05B	2nd Floor Power House	Roof outside north side of room looking east at former substation #4 area

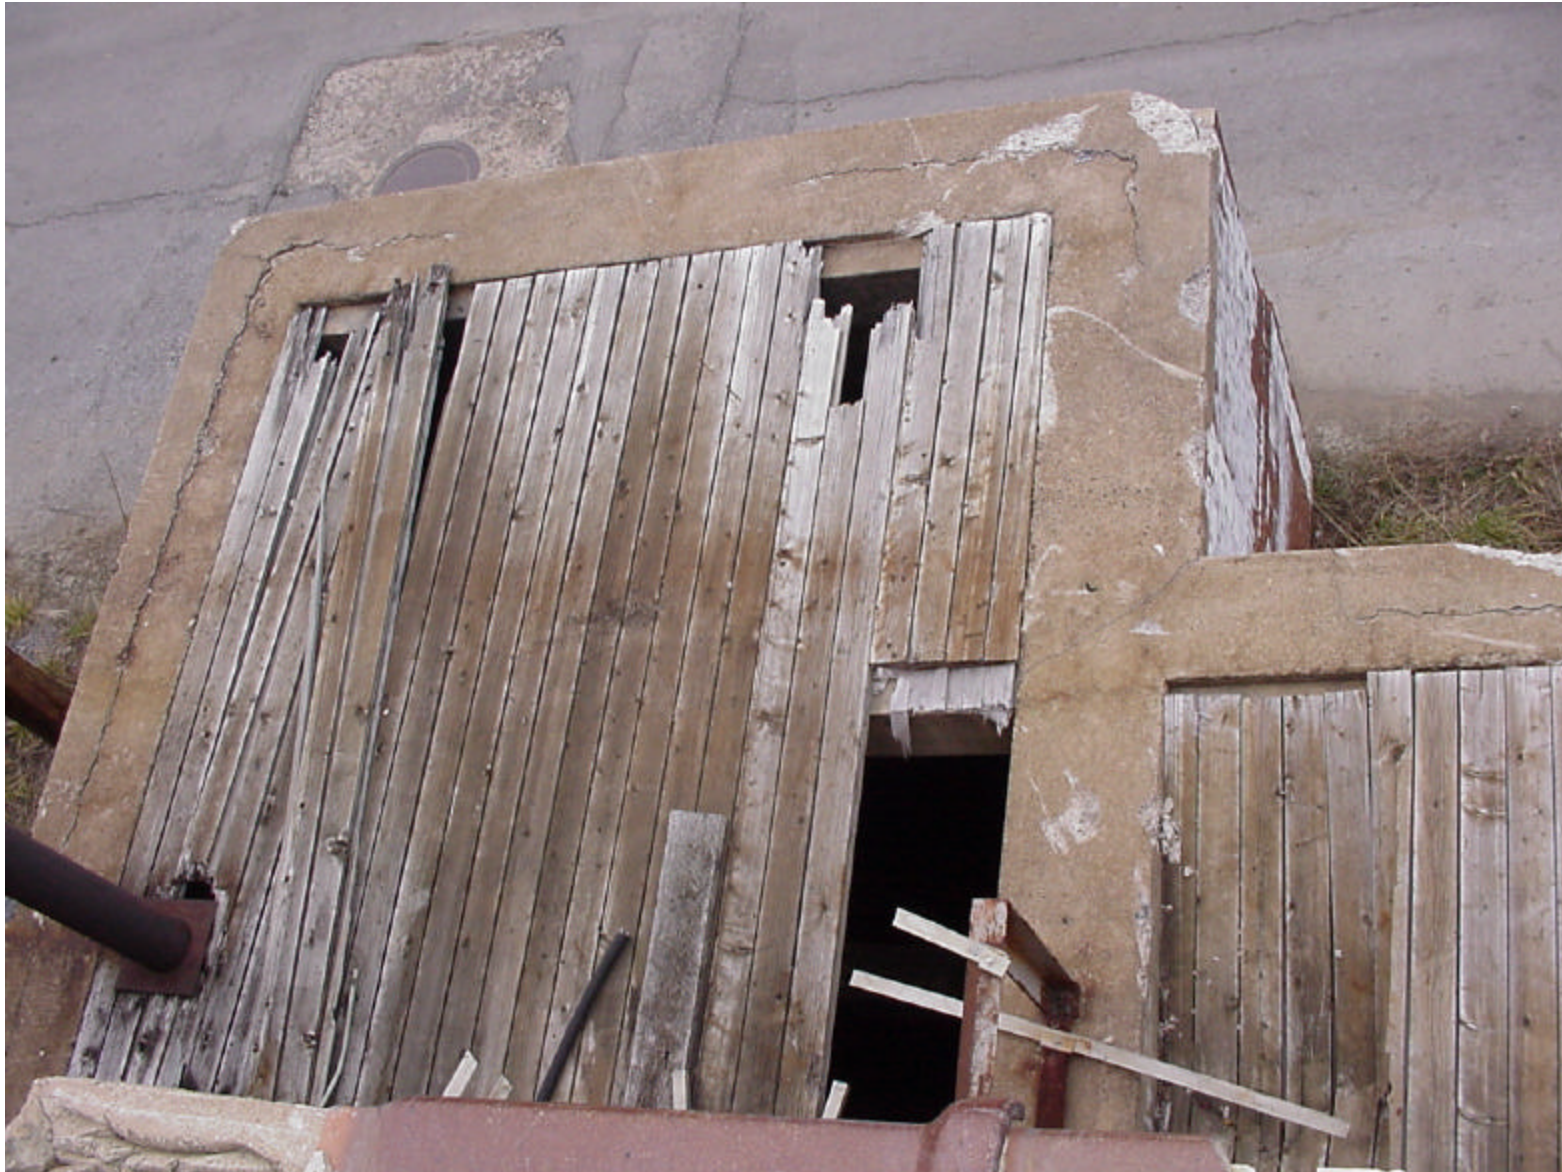
Photograph ID	Date Taken	Section #	Room #	Room Description	Description
MVC-737		VII	7.05B	2nd Floor Power House	Top of water tank which stored water from spray ponds, located in northwest corner of building

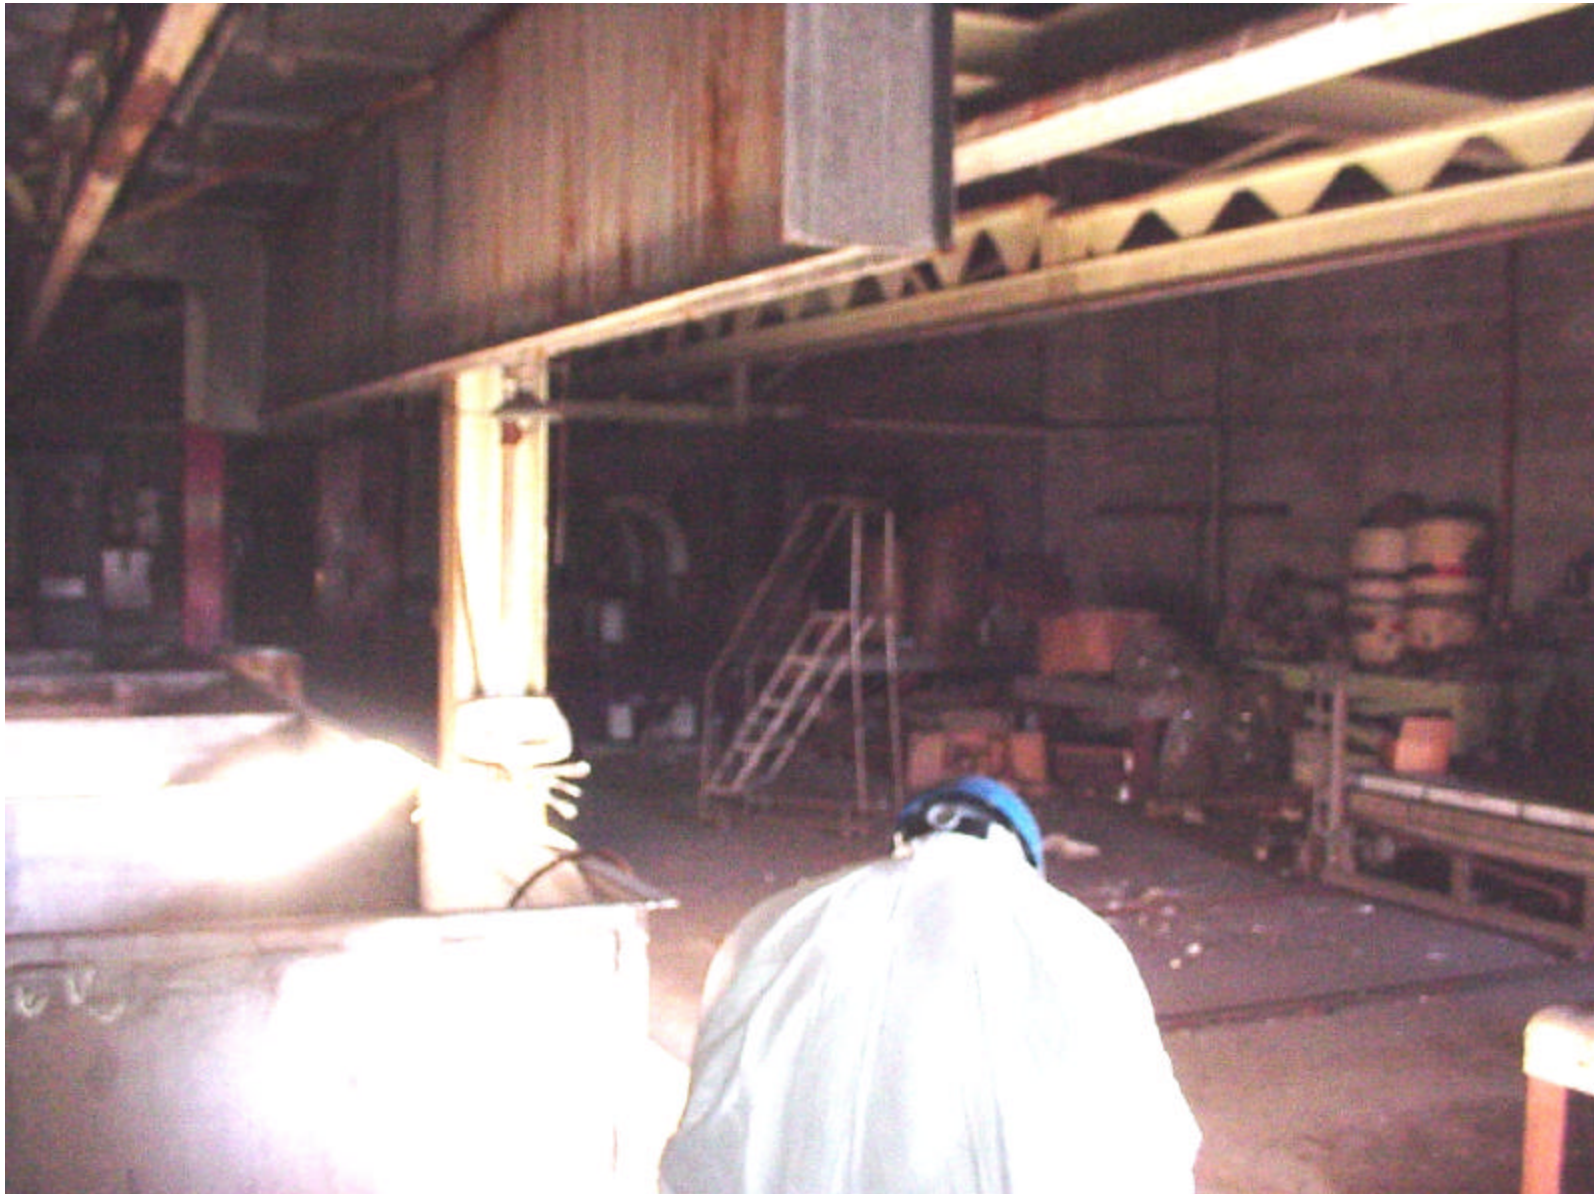
Photograph ID	Date Taken	Section #	Room #	Room Description	Description
MVC-069	11/17/99	I	1.03D	Creel Room 3rd Floor	View of room from northwest corner looking east.

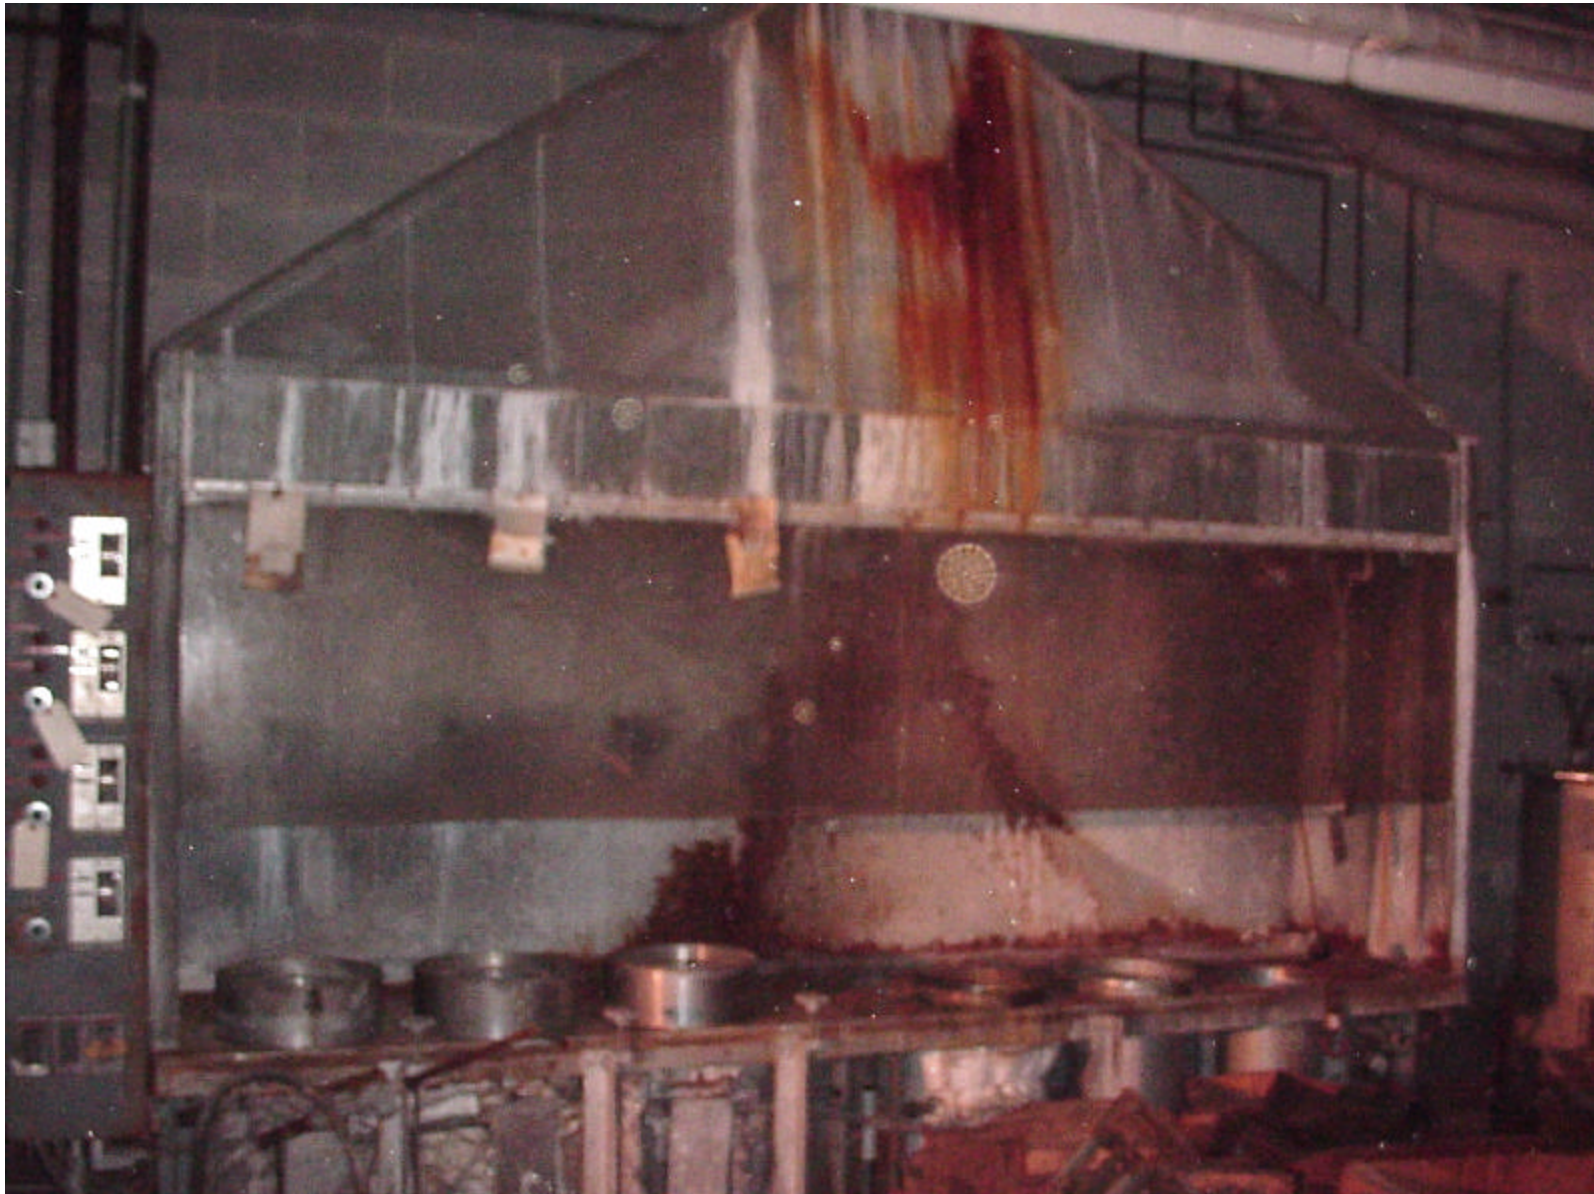
Photograph ID	Date Taken	Section #	Room #	Room Description	Description
MVC-071	11/17/99	I	1.03E	Creel Room 3rd Floor	Fume hood and smelting pots located along south wall of room.

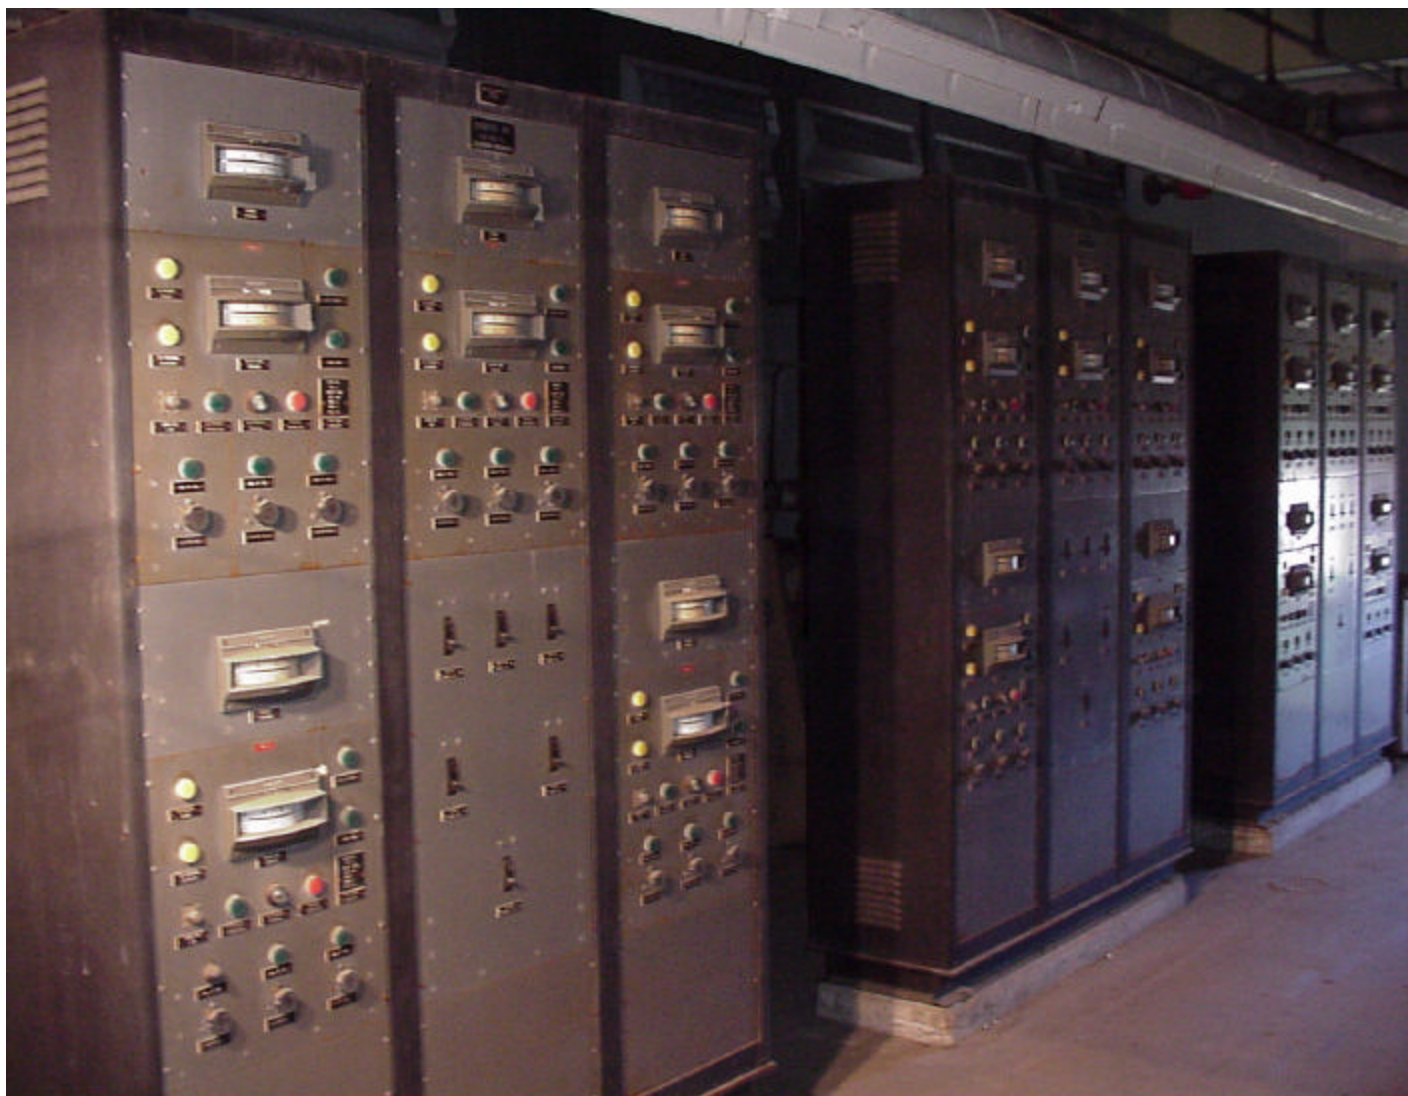
Photograph ID	Date Taken	Section #	Room #	Room Description	Description
MVC-173	11/18/99	I	1.04C	Polyester Spinning 3rd Floor	Control panels in southeast corner of room.
